Error Code U010 or N010 in GT Setup Tool

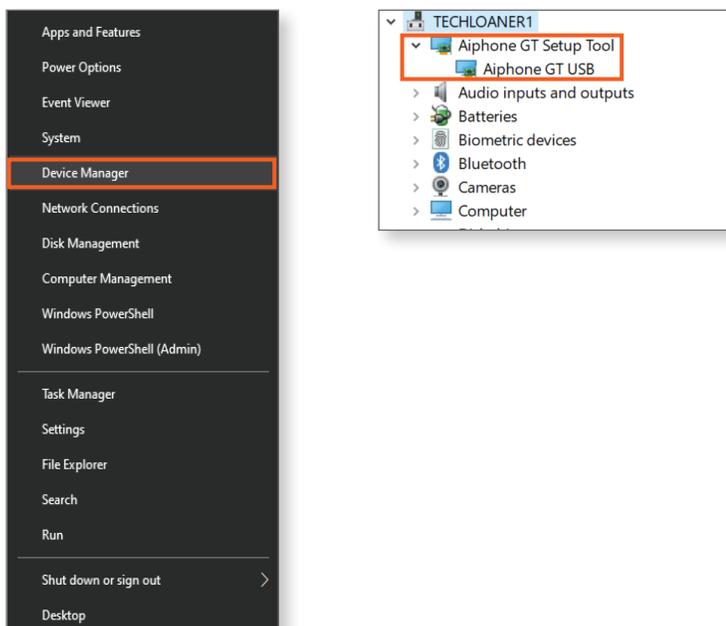
To access Device Manager, right click on the PC's start button. A menu will pop up, with Device Manager towards the middle of the list. The connection will appear as below. If it does not, try a different USB cable, or try a different USB port on the PC.

Make sure that the micro USB cable is firmly connected to both the programming PC and the GT Series station. As long as the connection is made, the U010 or N010 error is not caused by any sort of driver issue. The connection can be verified using the programming PC's Device Manager.

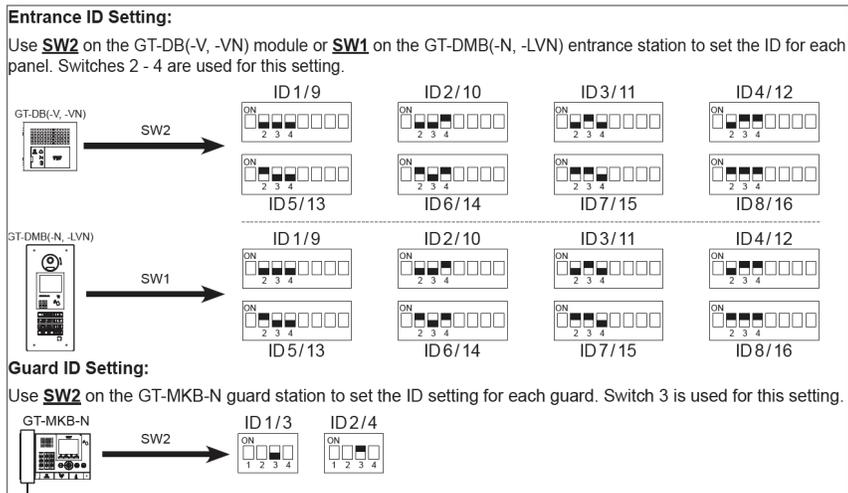
If there is more than one entrance panel or guard station on the system, make sure that each station is set to a unique ID. Entrance panels and guard stations count in the system differently, so there is no conflict if a guard station and an entrance panel share the same ID. If there is a GT-MCX on the system, it will occupy ID 1 for both guards and entrance panels. If an ID is changed, power cycle the station to let the change take effect. Disconnect both the power supply and **R1/R2** connection to perform the power cycle.
